## **HAMLET OF RHINECLIFF**

Town of Rhinebeck, New York

# **Traffic Study**

July 11, 2007

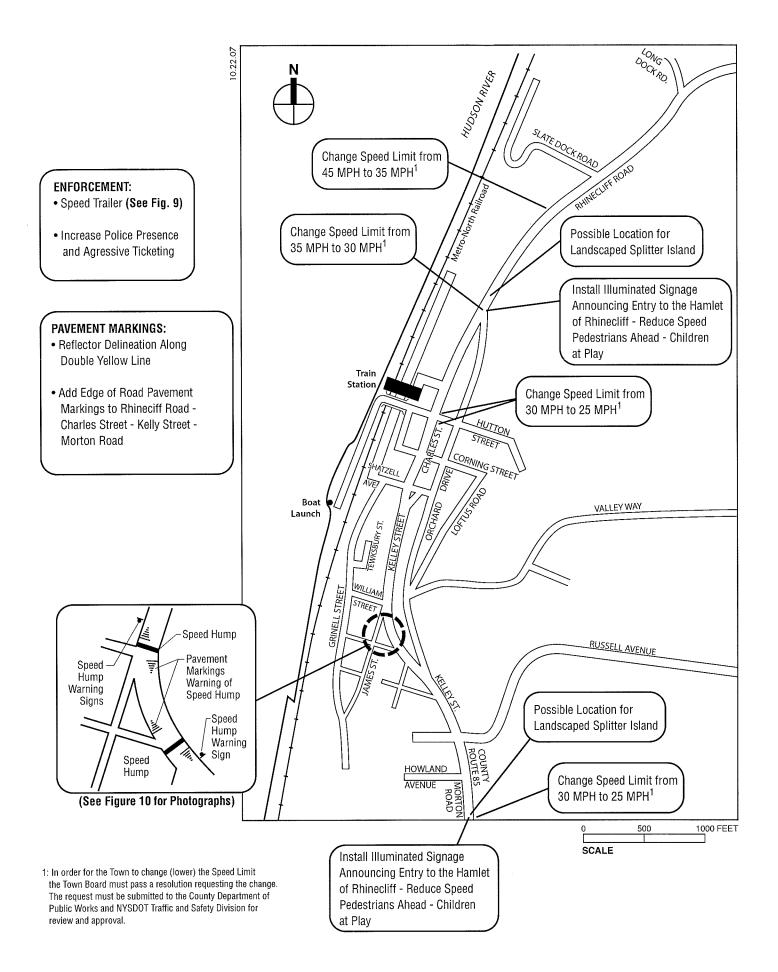
Figure 8 Improvement Plan

- Sharp and potentially dangerous horizontal curve located on Kelly Street where a bad accident occurred in 2005 between a bus and car. Speeding approximately 5 to 14 MPH above the warning 20 MPH signs posted at this location.
- Instances of speeding were recorded at the three locations shown on Figure 4. Speeds of approximately 15 to 30 MPH above the posted speed limits were recorded. Speeding generally occurred in the morning hours (6AM to 8AM) and late evening time periods (10 PM to 12 AM). The numbers of drivers exceeding the posted speed limit ranged between 1 and 10 percent depending on the location.
- Bicyclists that do not use the designated bike/hike trail on Grinell Street between Butler Street and Shatzell Avenue.
- Poorly marked streets faded or absent pavement markings on Hamlet Streets.
- No significant announcement signage upon entering the Hamlet.

Based on the information gathered for this study and from previous studies Rhinecliff Road/Charles Street/Kelly Street/Morton Road would benefit from the implementation of several traffic safety improvement measures. The measures outlined on Figure 8 (this is one possible improvement scenario that could be implemented to improve safety and maintain quality of life in Rhinecliff) are recommendations and it is not necessarily suggested that all measures be implemented. Rather Town officials, the Rhinecliff Traffic Committee, and Police officials decide which measures they think are the most effective and feasible for implementation. Once the committee decides on the measures to be implemented more detailed costs for installation can be determined based on consultation with the vendors of these products.
